Manhole Inspection Summary

Manhole # S2311_003MH

Insp Date: **7/23/08 2:34 PM**

Location Address: **2713 Eastshire DR**

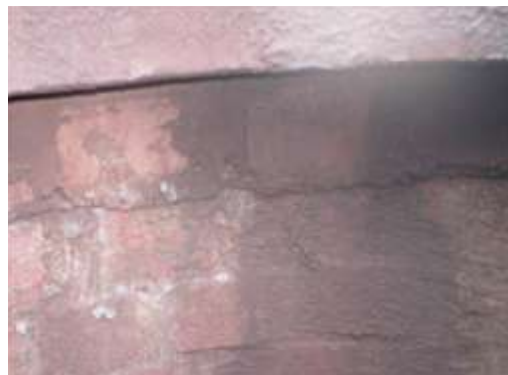
Defect 3

Infiltration: ☐ None ☒ **Joint** ☐ Cracks ☐ Mortar ☐ Roots ☐ Wall

chimney-frame joint infiltration

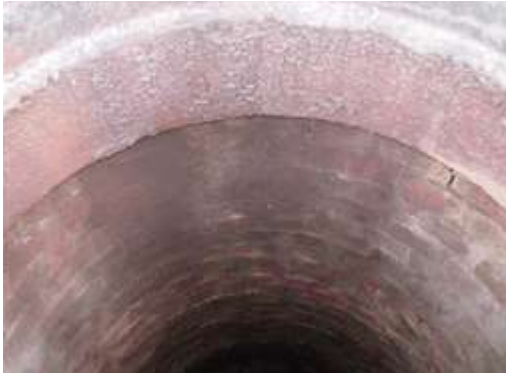
Defect 2

☒ **Leaks**

infiltration lid-frame

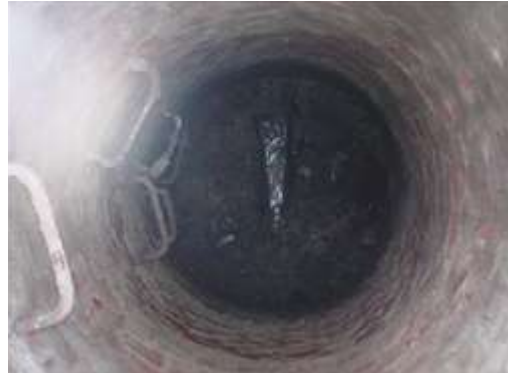
Defect 4

Count: **6** Missing: **0** ☒ **Corroded**

Steps Corroded

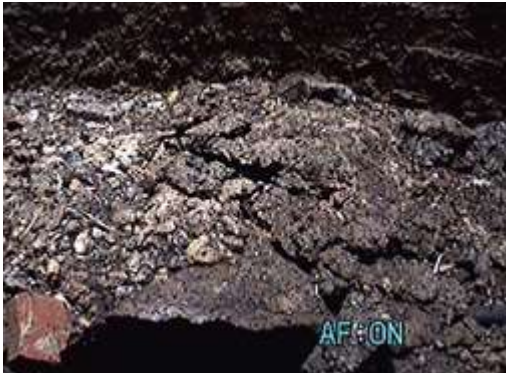
Defect 1

Condition: ☐ Sound ☐ Cracked ☐ Root Intrusion ☐ Deteriorated ☐ Leaks ☒ **Debris**

debris on bench

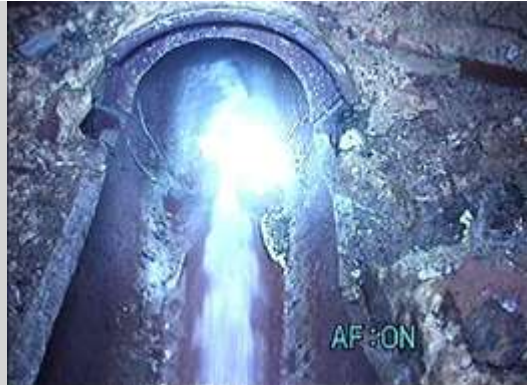
12 O'Clock Outflow

Pipe Height: **8.4** (in.) Rod and Bar (Angled)
Pipe Material: **Clay** ☐ Pipe Lined
Invert Depth: **11.15** (ft.) Flow Characteristics: **Fast**
Deposits: ☒ None ☐ Mud ☐ Sludge ☐ Debris ☐ Grease
Silt Depth: **0** (in.) Deposits Extent:
Infiltration: **None** Pipe Seal Cond: **Sound**

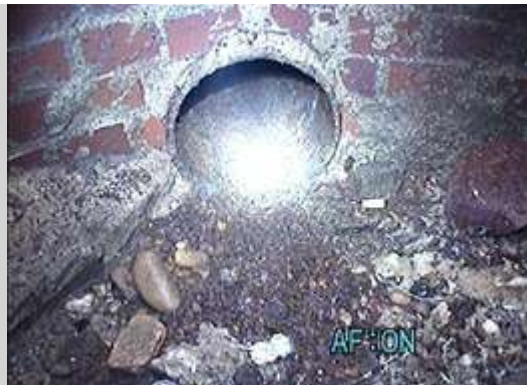
3 O'Clock Inflow

Pipe Height: **8.4** (in.) Rod and Bar (Angled)
Pipe Material: **Clay** ☐ Pipe Lined
Invert Depth: **10.45** (ft.) Flow Characteristics: **None**
Deposits: ☒ None ☐ Mud ☐ Sludge ☐ Debris ☐ Grease
Silt Depth: **0** (in.) Deposits Extent:
Infiltration: **None** Pipe Seal Cond: **Sound**

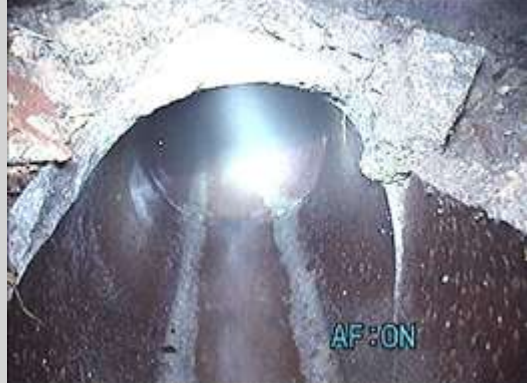
6 O'Clock Inflow

Pipe Height: **8.4** (in.) Rod and Bar (Angled)

Pipe Material: **Clay** ☐ Pipe Lined

Invert Depth: **10.95** (ft.) Flow Characteristics: **Fast**

Deposits: ☒ None ☐ Mud ☐ Sludge ☐ Debris ☐ Grease

Silt Depth: **0** (in.) Deposits Extent:

Infiltration: **None** Pipe Seal Cond: **Sound**
